REPORT OF  
PHASE I ENVIRONMENTAL SITE ASSESSMENT

**Troy Hill Corporate Center**  
Howard County, Maryland

MAY 1999

GTA Job No: 99204.E

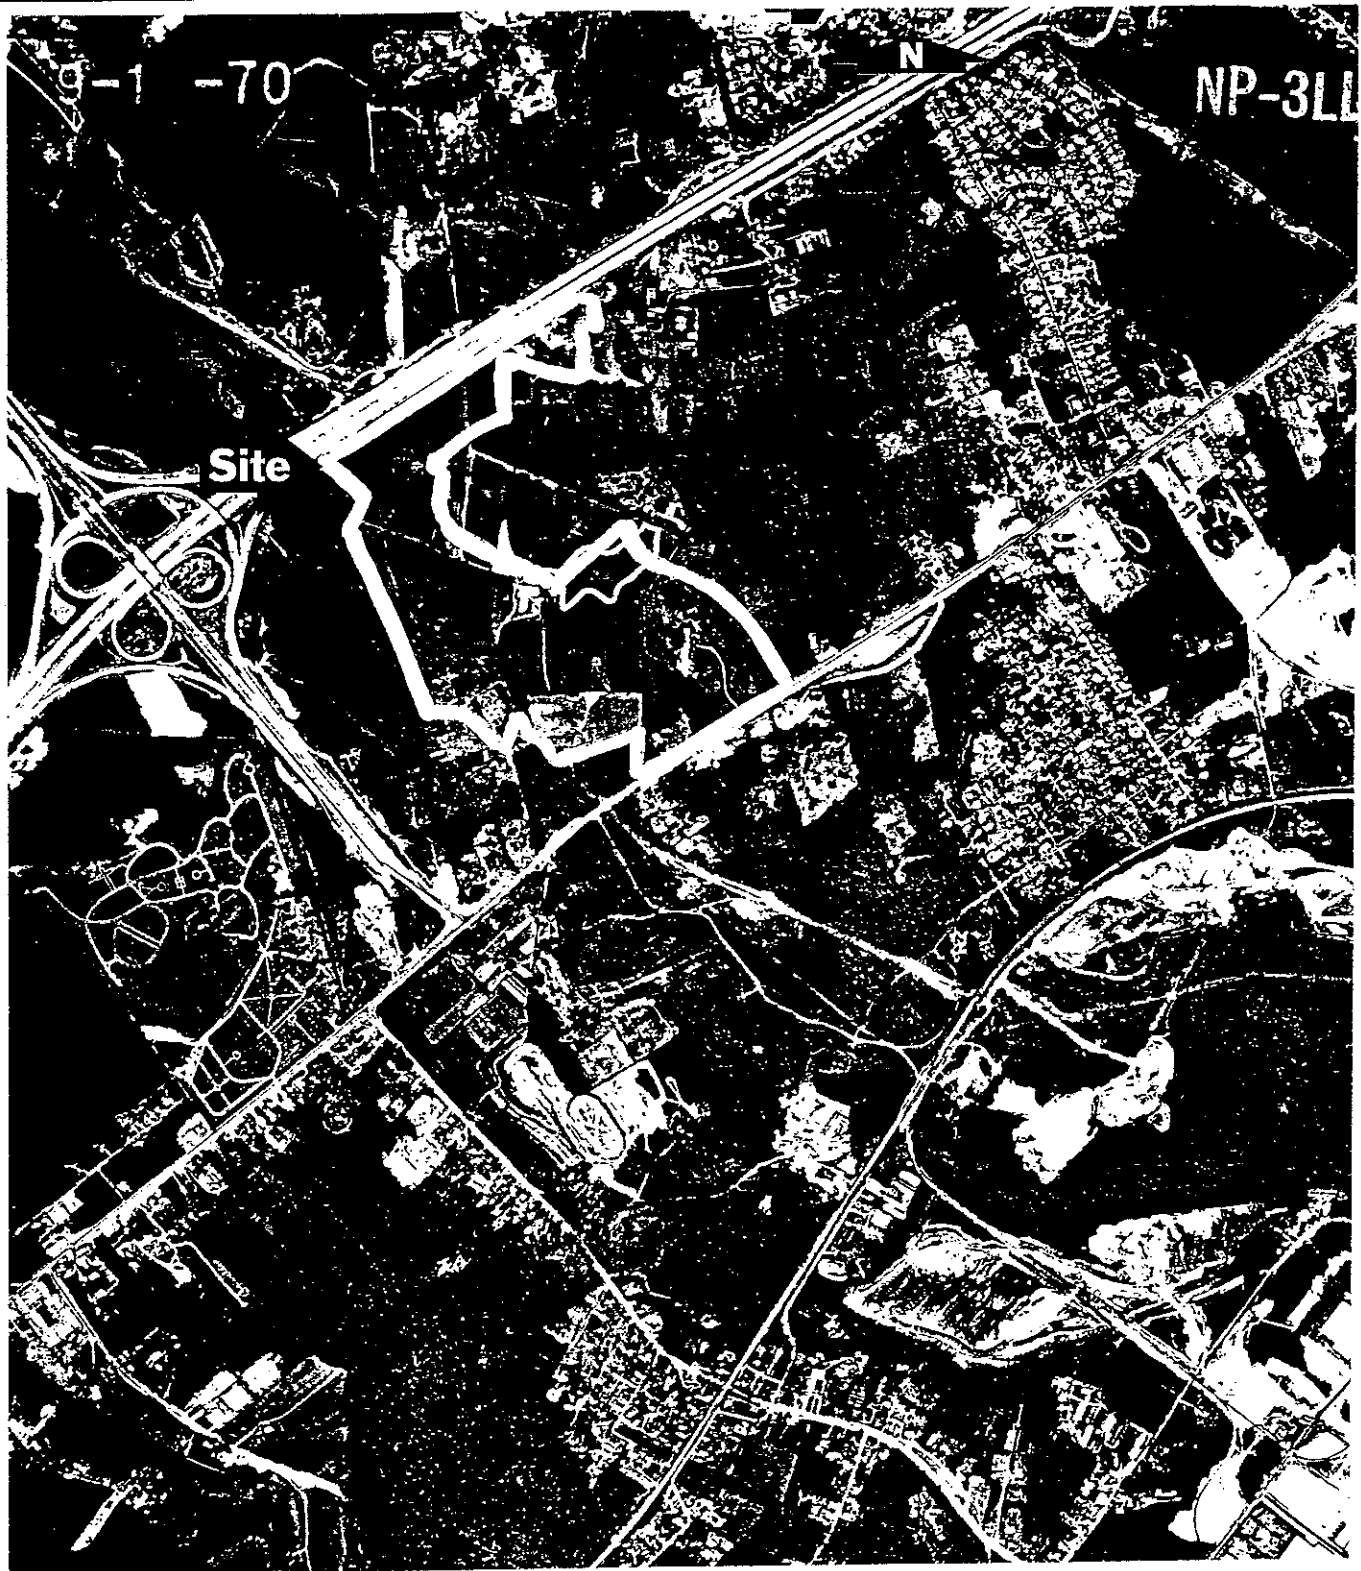
1970 AERIAL PHOTOGRAPH  
**TROY HILL CORPORATE CTR.**  
 Howard County, Maryland

The 1970 aerial photograph (Appendix C) indicates that the land uses on the subject property and in the surrounding region appeared to be similar to those that were observed on the 1963 aerial photograph. Interstate 95 had been constructed to the immediate north of the subject property. Maryland Route 100 and its interchange with Interstate 95 had been under construction to the west and southwest of the site. Some additional development of properties in the surrounding region had occurred, including residential neighborhoods in outlying areas from the site and small commercial sites along U.S. Route 1.
